TEST REPORT

Report number: GTS20250606013-1-01

Applicant	CLOVER INDUSTRIAL CO., LTD
Manufacturer	CLOVER INDUSTRIAL CO., LTD
Product name	Laptop
Product model	143N/U
Approval Types	Commission Test

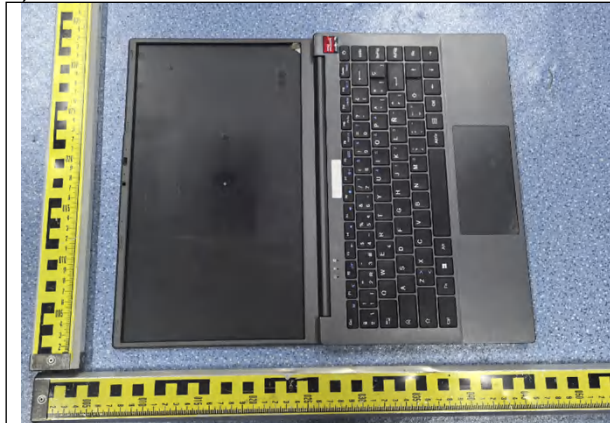
Before the test

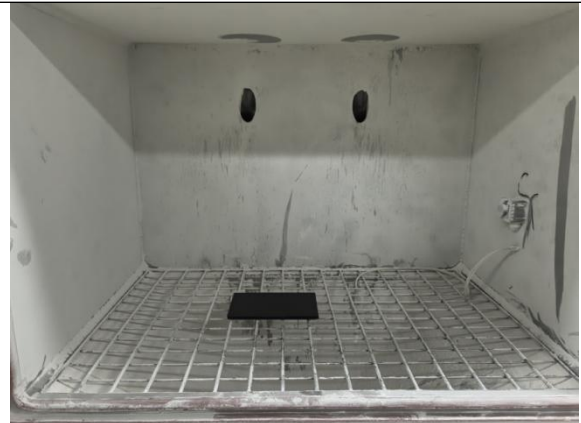
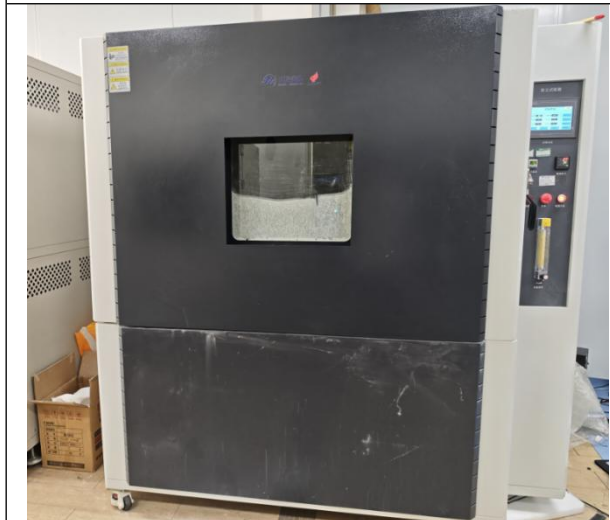
Use a test probe with a diameter of 1 mm and apply a force of 1 N to pierce the sample's gap area.

(1).Continuous dust blowing for 8 hours;

(2). Dust content in the dust-proof box: 2 kg/m³.

Experiment Process

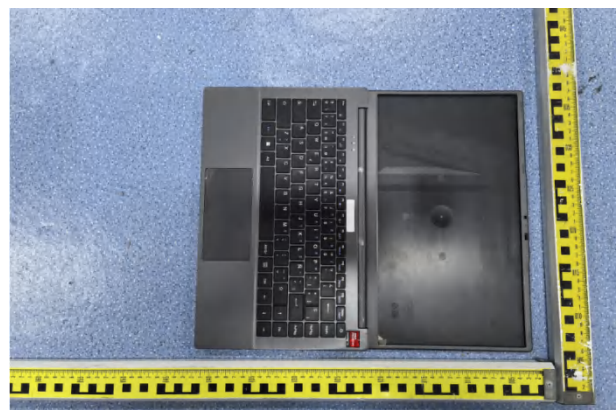
After the test

5) After the test, there was no dust intrusion inside the sample, and it was qualified.

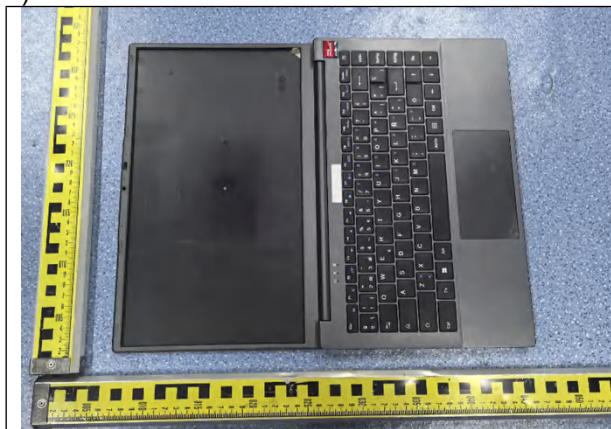
Before the test

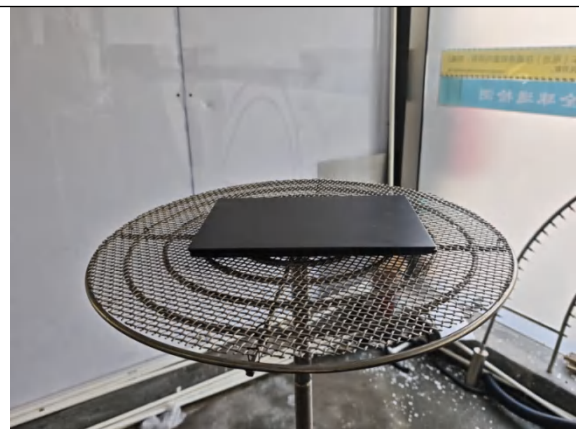
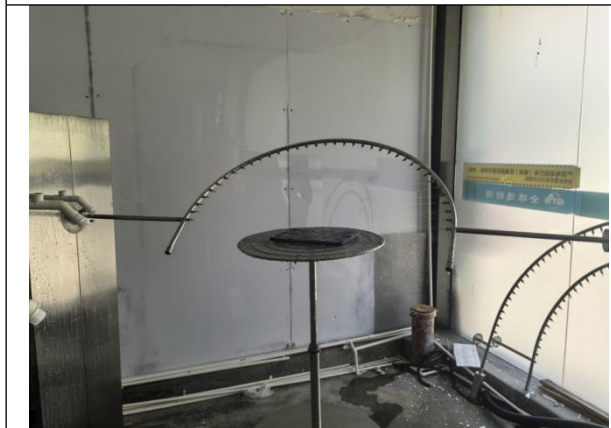
1) Pinholes: 36;

2) Test water flow rate: 2.3 L/min;

3) Test duration: 10 minutes;

Experiment Process
